BECI Field Report

Perdido Sun
13753 Perdido Key Dr.
Pensacola, FL 32507

FIELD REPORT NO: **PRDDSN003**

SITE VISIT DATE: **10/15/2024**

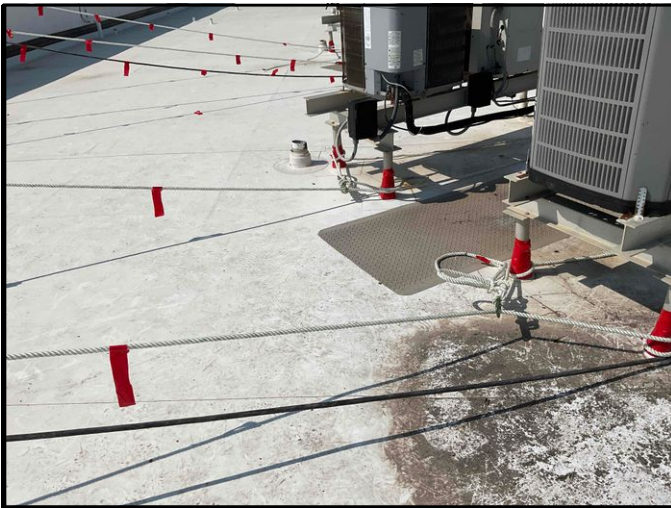
- 3.2 At the roof of the Building, crew members had begun staging for the swing stage installation. Care was taken to protect the new roof membrane from damage, and tape was used to protect and prevent damage to the HVAC Equipment platform legs from the staging rope (Reference Figure 1). At the metal copings, C/Sharpe used fabric material around the ropes and cords to ensure the newly installed metal components were protected (Reference Figure 2). Brian Jackson with C/Sharpe stated that precautions were taken to ensure the roof remained in good condition. Overall, the protection installed at the Building appeared to be in accordance with Technical Specification Sections 01000 and 01732 of BE-CI's Project Manual.

FIGURE 1 - Roof - View of red tape installed around HVAC Equipment Platform legs for protection.

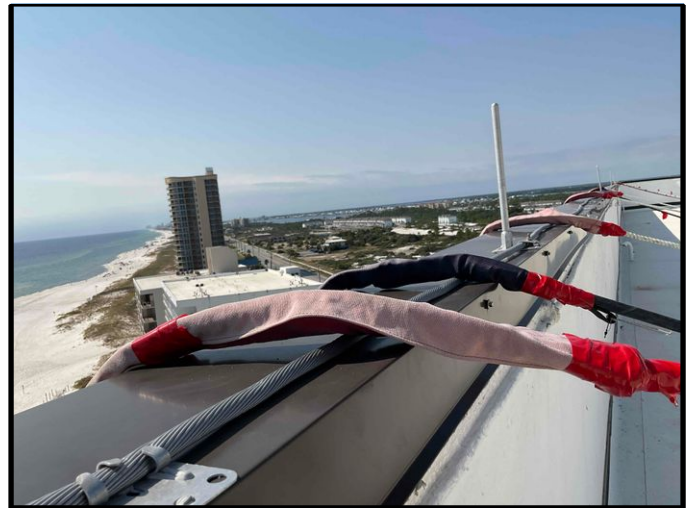
FIGURE 2 - Roof - View of fabric installed at staging cables and cords to protect metal coping.

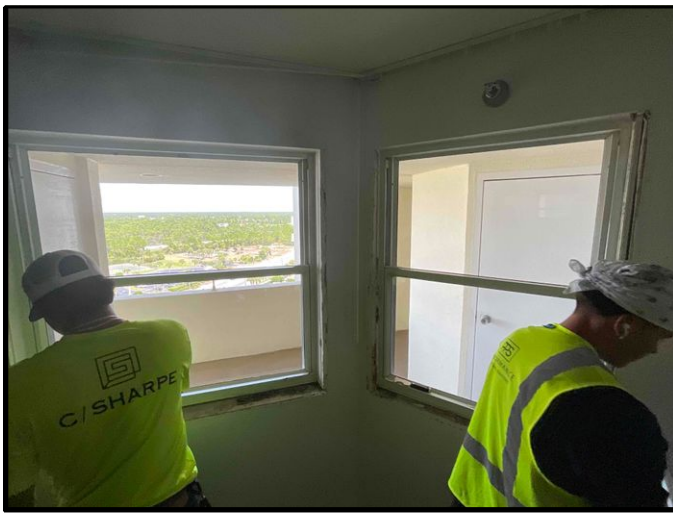
- 3.3 We observed that in Unit No. 1104, existing windows were being removed for replacement (Reference Figures 3 and 4). Additionally, we noted in Unit No. 1102 that new untreated lumber was installed at the rough opening for new window installation. Prosoco R-Guard FastFlash, a Liquid Flashing Membrane, was in the process of being applied to the inside corners, joints, seams, and framing surfaces at a minimum of 12 mils (Reference Figures 5 and 6). At the joint between the rough opening and existing cladding, FastFlash was also installed. The joint between the rough opening and existing cladding was approximately 1/4" so no backer rod was required per Prosoco's Installation Instructions. Any joint found during the replacement that is between 3/8" and 1" shall have backer rod and R-Guard FastFlash. Overall, the window replacement preparation appeared to be in accordance with the Manufacturer's Installation Instructions and BECI's Project Manual & Drawings and Details.

FIGURE 3 - Unit No. 1104 - View of existing windows being removed for replacement.

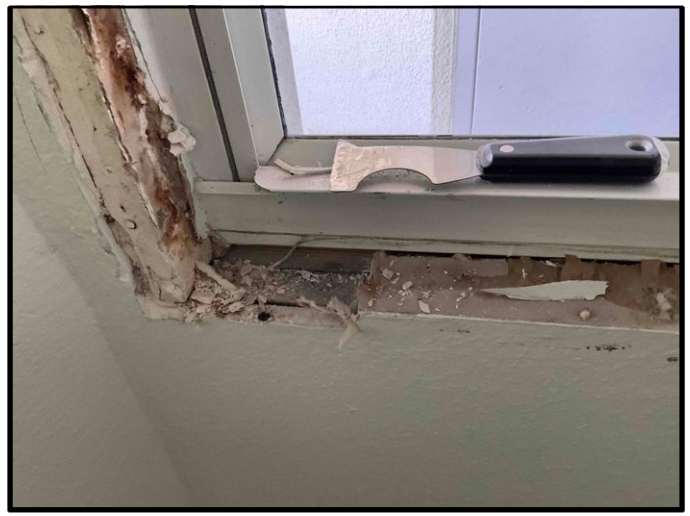
FIGURE 4 - Unit No. 1104 - View of existing windows being removed for replacement.

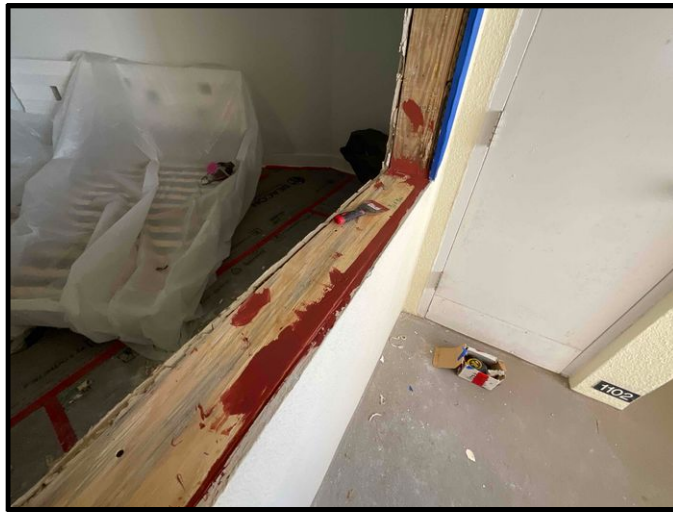
FIGURE 5 - Unit No. 1102 - View of new untreated lumber installed and R-Guard installed to inside corners.

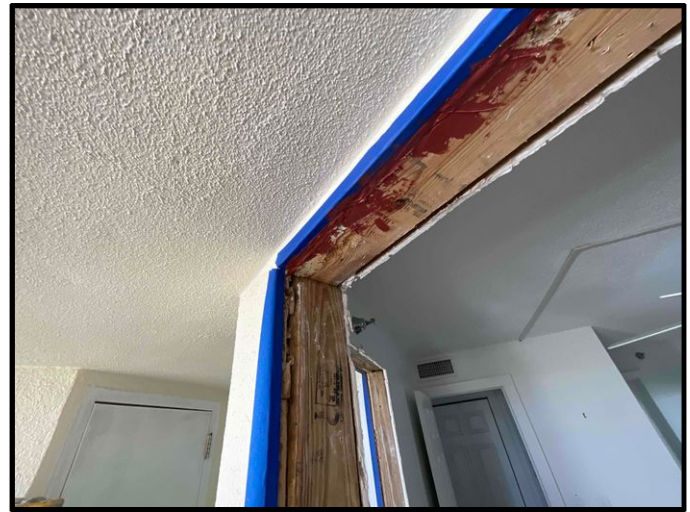
FIGURE 6 - Unit No. 1102 - View of new untreated lumber installed and R-Guard installed to inside corners.

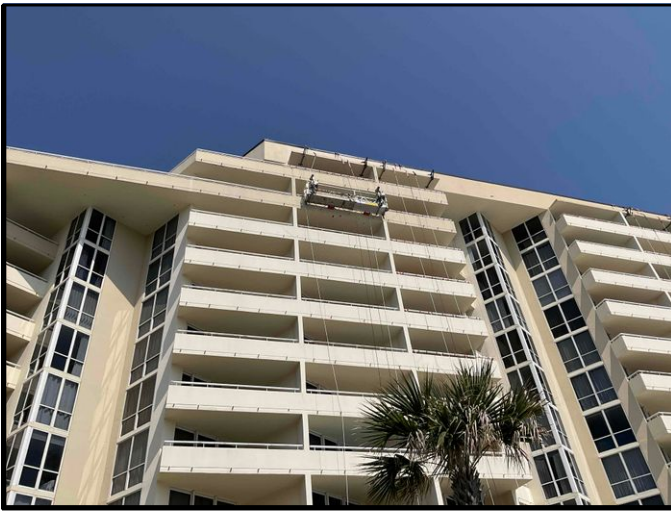
We observed crew members utilizing a swing stage for concrete repairs at the South Elevation, specifically at the 12 Stack Private Balconies (Reference Figure 7). Additionally, we noted a rod chair repair mock-up in progress at Unit No. 912 (Reference Figure 8). Furthermore, there was a partial depth repair mock-up also underway at Unit No. 912 (Reference Figure 9). Lastly, we observed that a partial depth repair to be completed at the balcony deck of Unit No. 312 (Reference Figure 10). All concrete repairs should be completed following the International Concrete Repair Institutes (ICRI) Guidelines. BECI will continue to monitor the mock-up repair steps as they are completed.

FIGURE 7 - South Elevation - View of crew members utilizing swing stage for concrete repairs at 12 Stack Private Balconies.

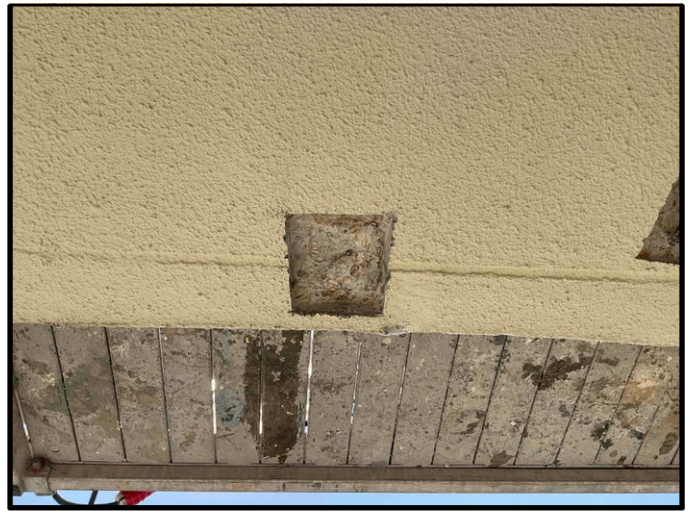
FIGURE 8 - Unit No. 912 - View of rod chair repair mock-up in progress.

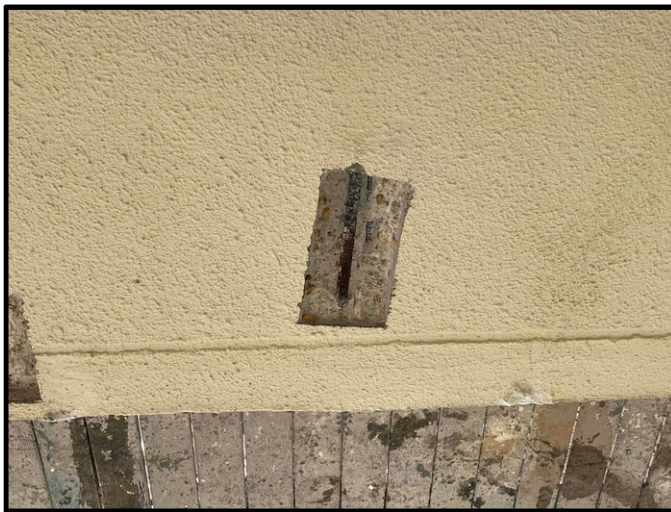
FIGURE 9 - Unit No. 912 - View of partial depth repair mock-up in progress.

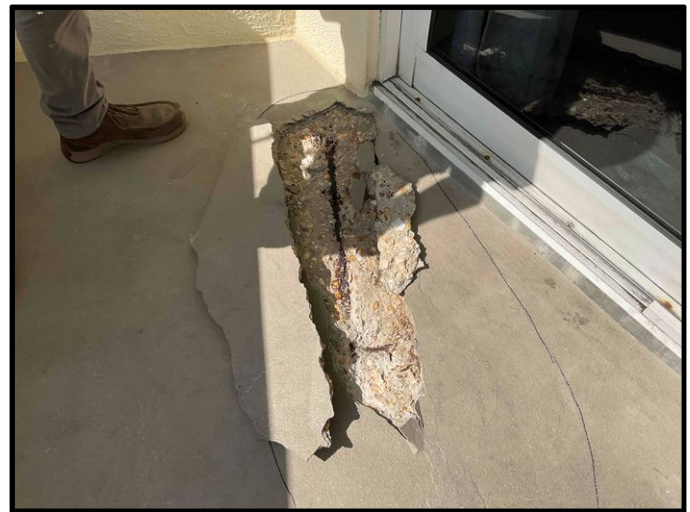
FIGURE 10 - Unit No. 312 - View of partial depth repair to be completed at balcony deck.

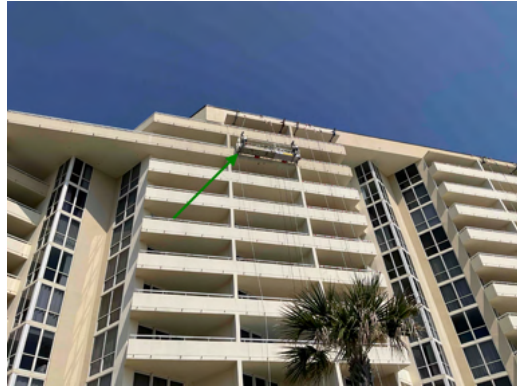
Photo 2
South Elevation - View of crew members utilizing swing stage for concrete repairs at 12 Stack Private Balconies.

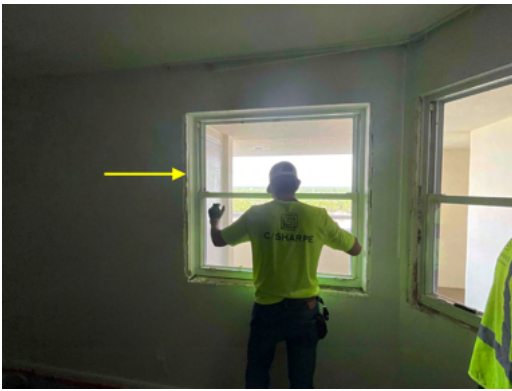
Photo 3
Unit No. 1104 - View of existing windows being removed for replacement - Work in Progress.

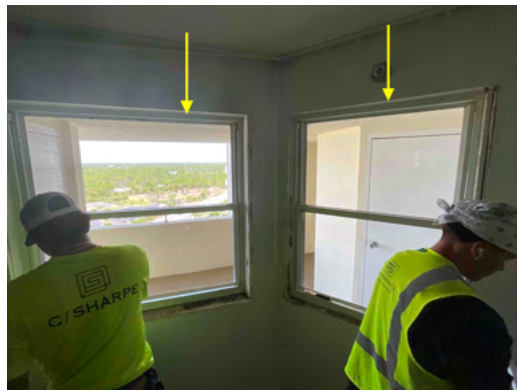
Photo 4
Unit No. 1104 - View of existing windows being removed for replacement - Work in Progress.

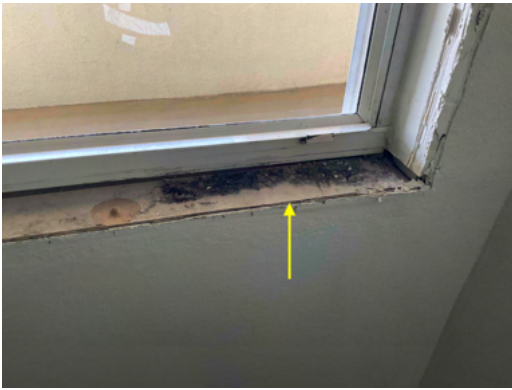
Photo 5
Unit No. 1104 - View of existing lumber bucking to be removed and replaced - Work in Progress.

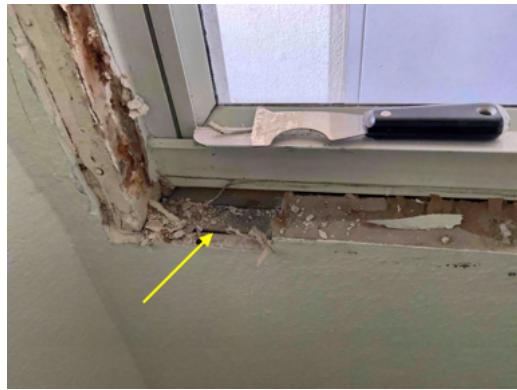
Photo 6
Unit No. 1104 - View of existing window being removed for replacement - Work in Progress.

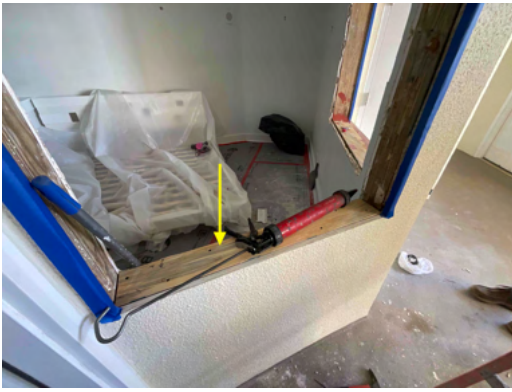
Photo 7
Unit No. 1102 - View of existing window removed - Work in progress.

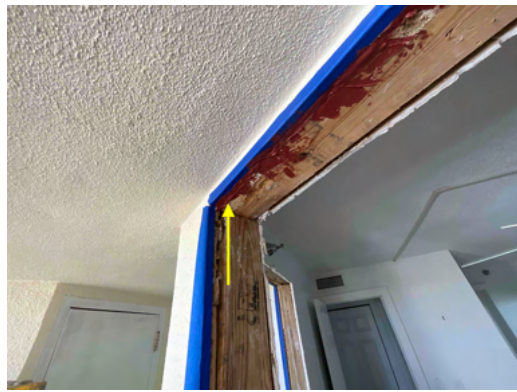
Photo 8
Unit No. 1102 - View of new untreated lumber installed and R-Guard installed to exterior joints between substrates.

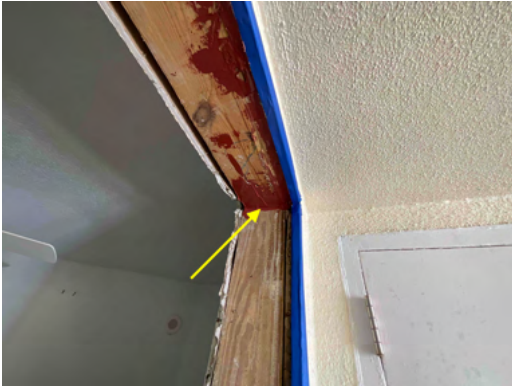
Photo 9
Unit No. 1102 - View of new untreated lumber installed and R-Guard installed to inside corners.

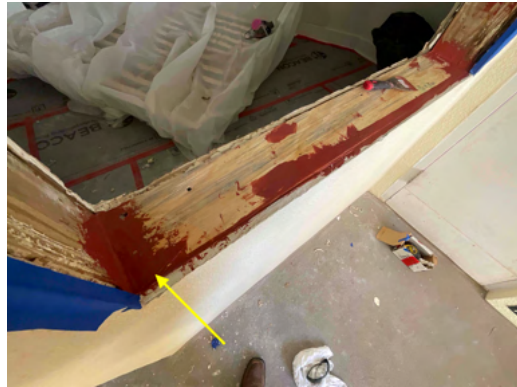
Photo 10
Unit No. 1102 - View of new untreated lumber installed and R-Guard installed to inside corners.

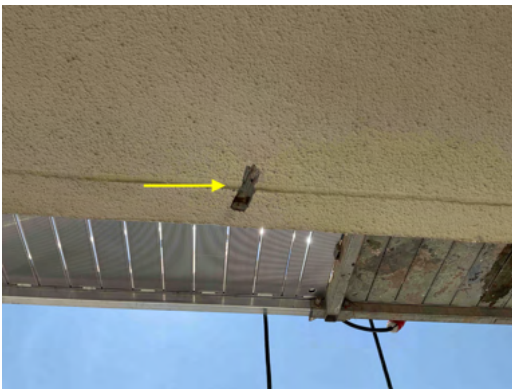
Photo 11
Unit No. 912 - View of rod chair repair mock-up in progress - Work in Progress.

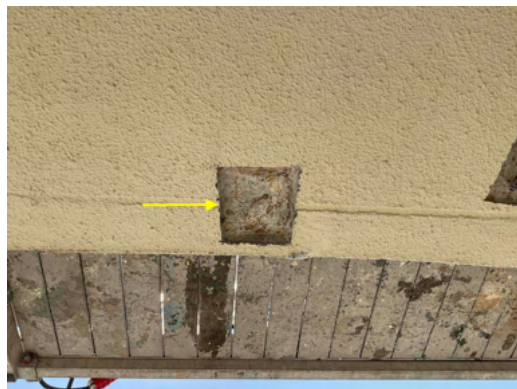
Photo 12
Unit No. 912 - View of rod chair repair mock-up in progress - Work in Progress.

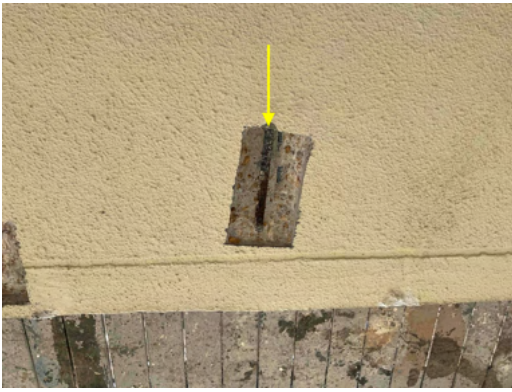
Photo 13
Unit No. 912 - View of rod chair repair mock-up in progress
- Work in Progress.

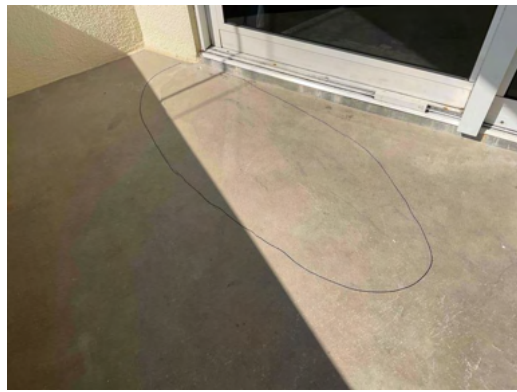
Photo 14
Unit No. 312 - View of partial depth repairs marked for
demolition - Work in Progress.

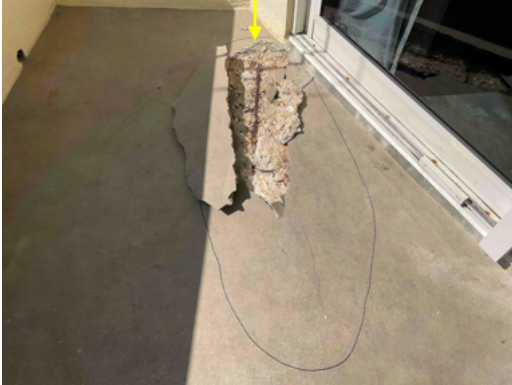
Photo 15
Unit No. 312 - View of partial depth repair to be completed
at balcony deck. - Work in Progress.

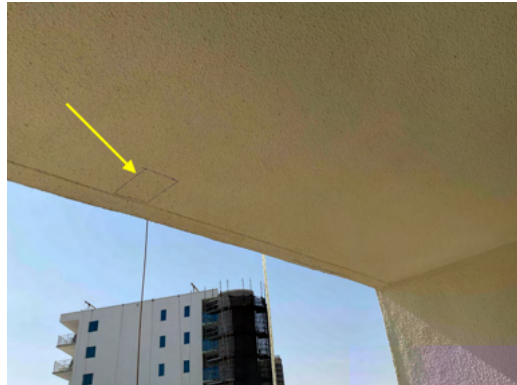
Photo 16
Unit No. 312 - View of concrete repairs marked for
demolition - Work in Progress.

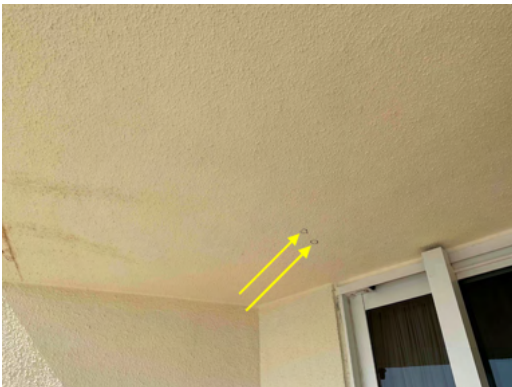
Photo 17
Unit No. 912 - View of concrete repairs marked for
demolition - Work in Progress.

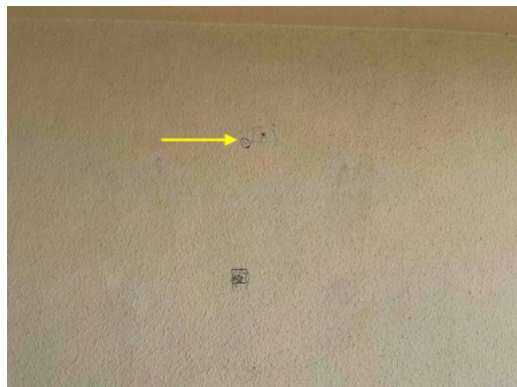
Photo 18
Unit No. 912 - View of concrete repairs marked for
demolition - Work in Progress.

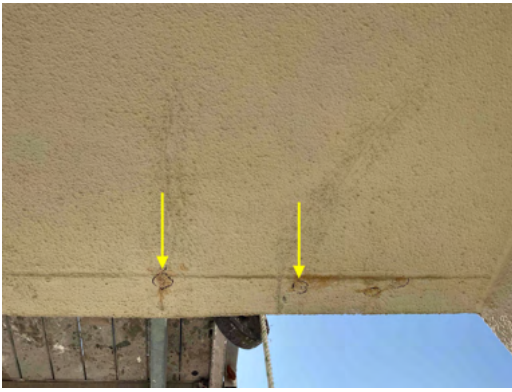
Photo 19
Unit No. 912 - View of concrete repairs marked for demolition - Work in Progress.

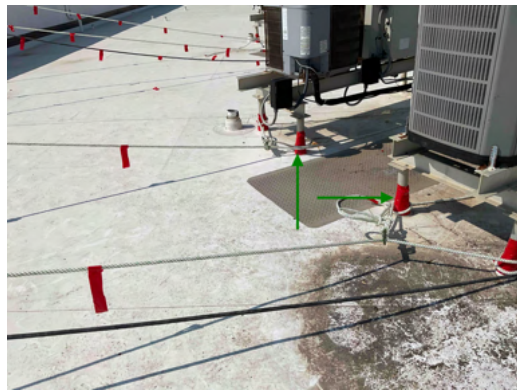
Photo 20
Roof - View of red tape installed around HVAC Equipment Platform legs for protection.

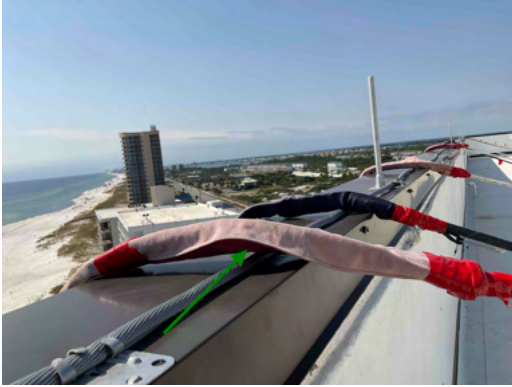
Photo 21
Roof - View of fabric installed at staging cables and cords to protect metal coping.

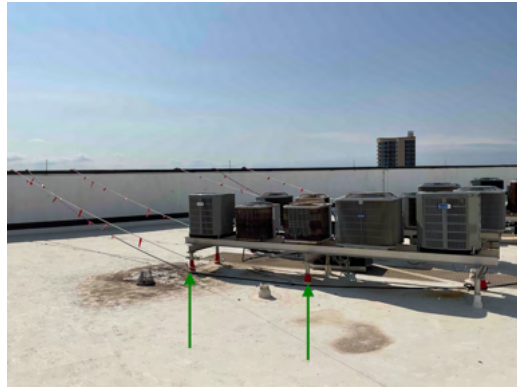
Photo 22
Roof - View of red tape installed around HVAC Equipment Platform legs for protection.

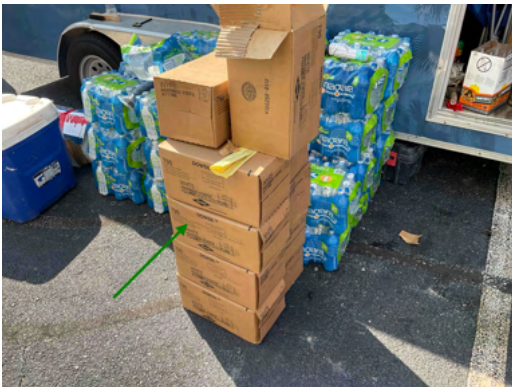
Photo 23
Materials On-Site - View of approved DowSil 790 silicone sealant stored.

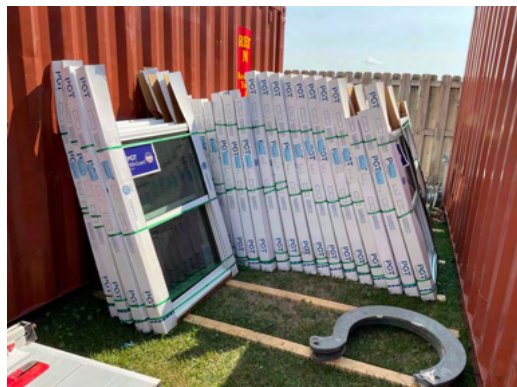
Photo 24
Materials On-Site - View of approved PGT SH5500 Windows stored for window replacement.
