BECI Field Report

Perdido Sun
13753 Perdido Key Dr.
Pensacola, FL 32507

FIELD REPORT NO: **PRDDSN004**

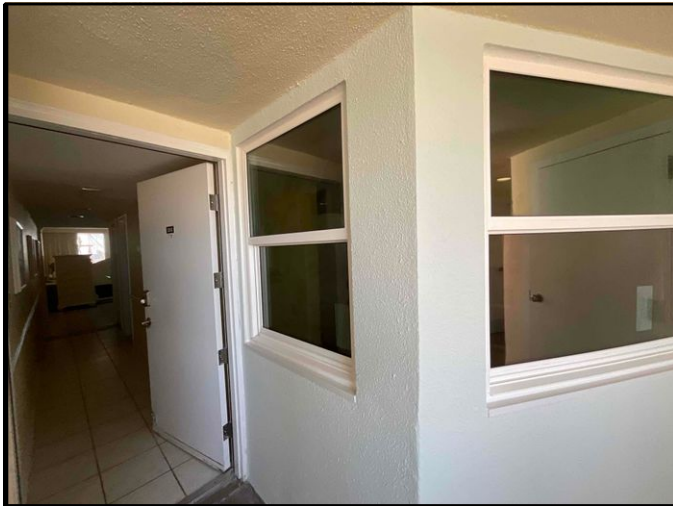
- 4.2 We observed that the new common walkway window mock-up at the exterior walkway has been completed, with a new coating application applied to the exterior wall for review (Reference Figure 1). Additionally, we noted that the new common walkway window mock-up at the interior bedroom has been completed, with new trim pieces installed (Reference Figure 2). Furthermore, we observed that the new interior trim pieces installed at the window had new sealant applied from the frame to the trim and from the trim to the wall (Reference Figures 3 and 4). The new window, sealant, and trim pieces appeared to be in good condition and installed perfectly Manufacture Guidelines.

FIGURE 1 - Until No. 202 - View of new common walkway window mock-up completed at exterior walkway - Good Condition.

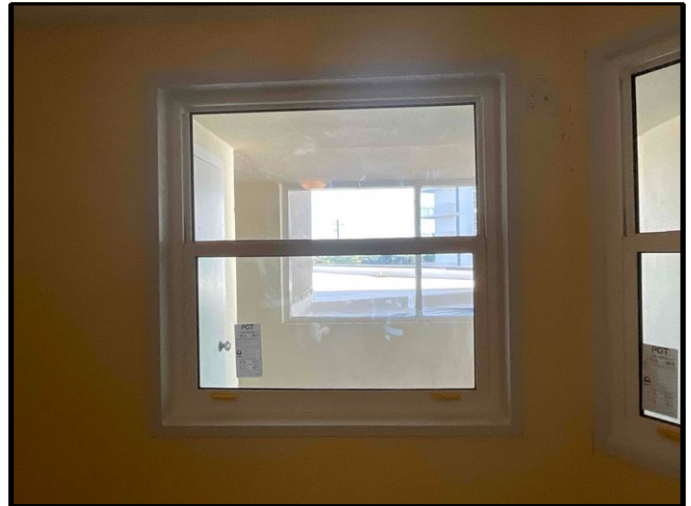
FIGURE 2 - Until No. 202 - View of new common walkway window mock-up completed at interior bedroom - Good Condition.

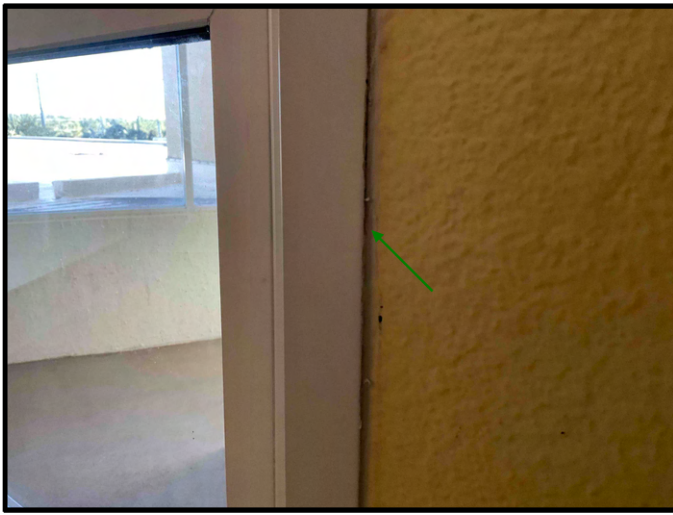
FIGURE 3 - Unit No. 202 - View of new interior trim pieces installed at window with new sealant installed from frame to trim and from trim to wall.

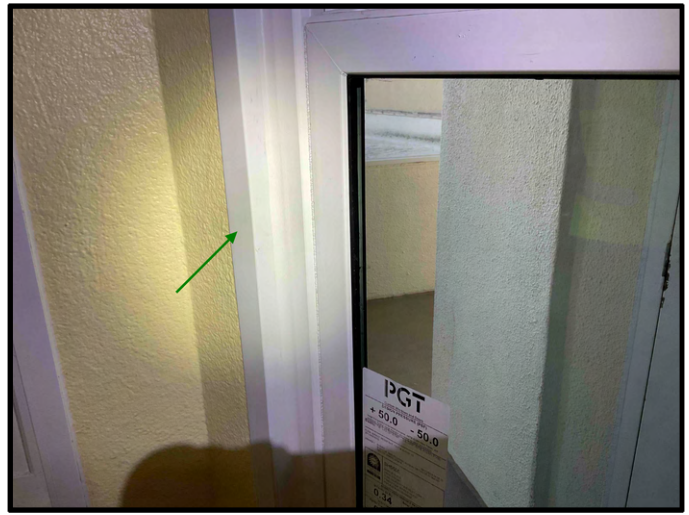
FIGURE 4 - Unit No. 202 - View of new interior trim pieces installed at window with new sealant installed from frame to trim and from trim to wall.

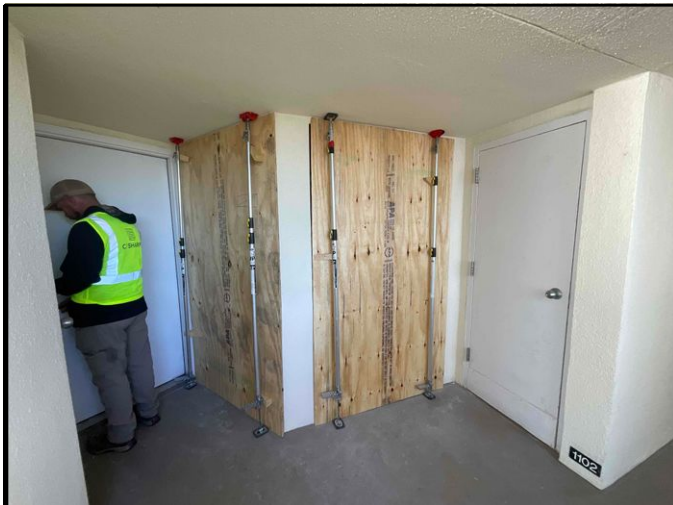
We observed the installation of exterior protection at the window replacement locations at Unit Nos. 1102, 1104, and 1110 (Reference Figure 5). The exterior lumber was installed to protect the unit interior from exterior conditions while the newly applied waterproofing dried. The lumber will stay in place until the new window is installed. Additionally, we noted the installation of new sill flashing at one (1) of the window rough openings in Unit No. 1104 (Reference Figure 6), however, C/Sharpe installed the flashing without embedding it in sealant (Reference Figure 7). It was discussed with Brian Jackson (C/Sharpe) that he was aware of the installation error and that they planned to remove the flashing, touch up the waterproofing and then embed the flashing in sealant. Furthermore, we observed the application of new FastFlash waterproofing at the window rough openings in Unit Nos. 1102, 1104, 1110 (Reference Figure 8), and observed that this application was in progress at Unit No. 1112. At the newly applied FastFlash, we observed locations where pinholes or voids existed, and it was discussed with Brian that they planned to touch up those areas once the first coat dried. Overall, the window rough opening preparation appeared to typically be performed in accordance with Manufacturer Guidelines and BECI's Project Manual.

FIGURE 5 - Unit No. 1102 - View of exterior protection installed at window replacement location.

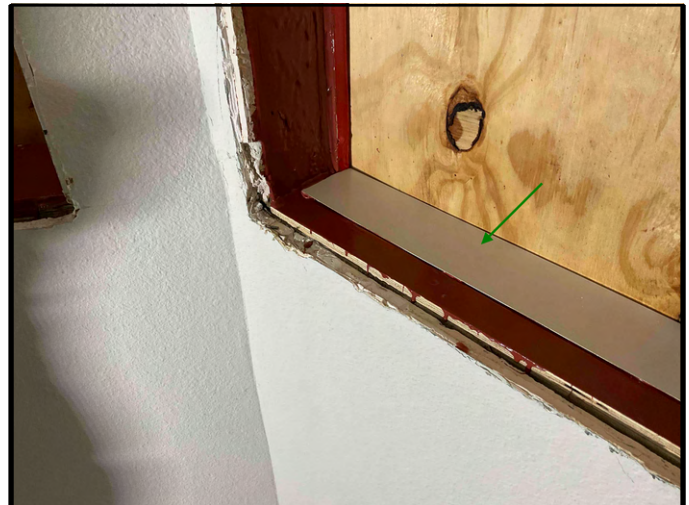
FIGURE 6 - Unit No. 1104 - View of new sill flashing installed at window rough opening.

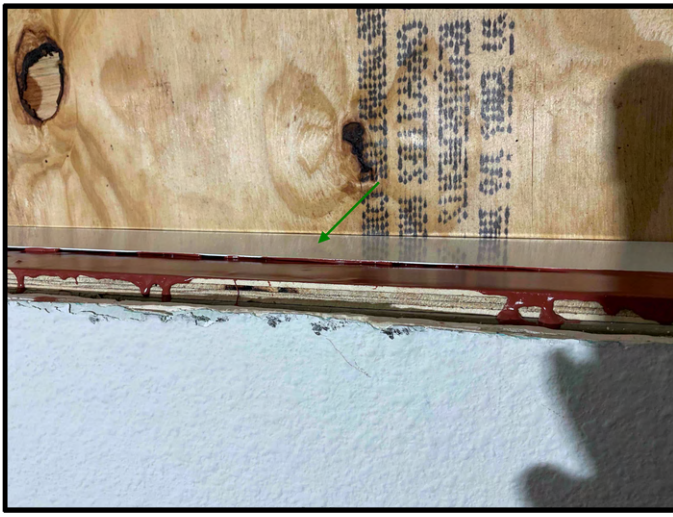
FIGURE 7 - Unit No. 1104 - View of new sill flashing installed at window rough opening, not embedded in sealant.

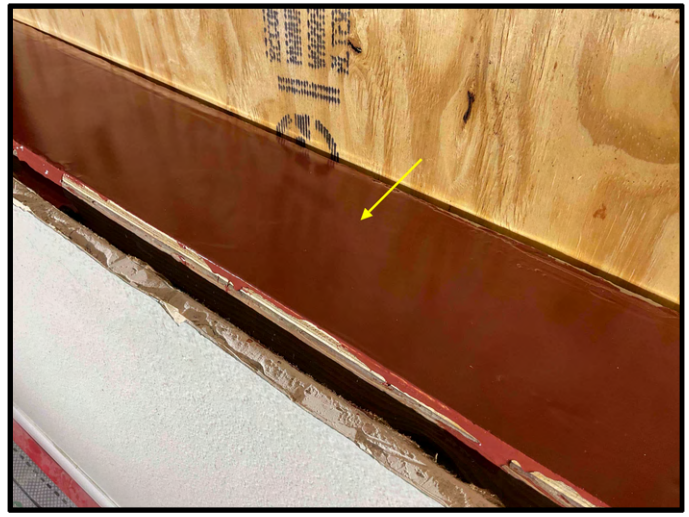
FIGURE 8 - Unit No. 1110 - View of new FastFlash waterproofing installed at window rough opening - Work in Progress.

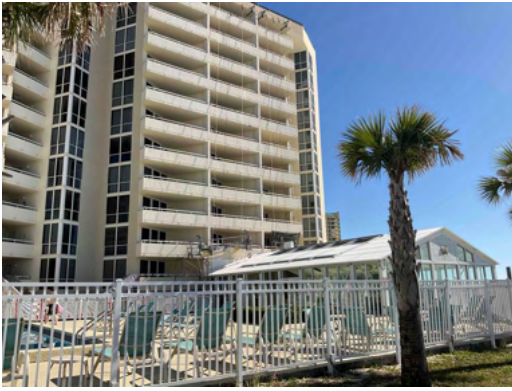
Photo 1

South Elevation - Overall view.

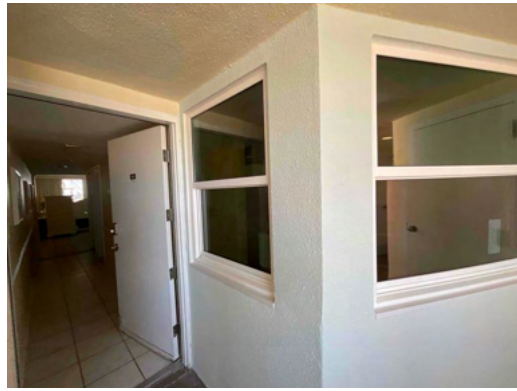
Photo 2

Unit No. 202 - View of new common walkway window mock-up completed at exterior walkway - Good Condition.

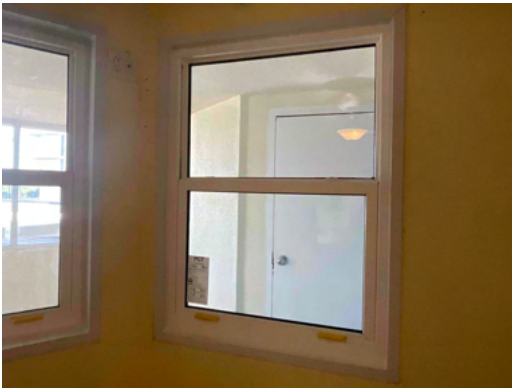
Photo 3

Unit No. 202 - View of new common walkway window mock-up completed at interior bedroom - Good Condition.

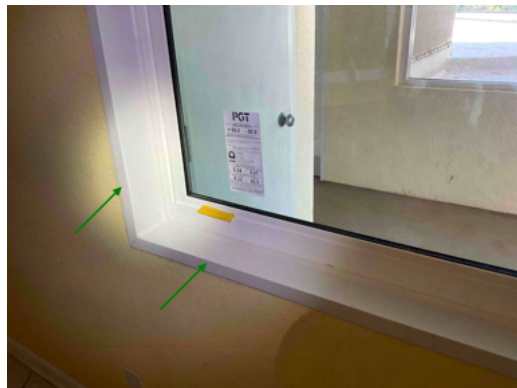
Photo 4

Unit No. 202 - View of new interior trim pieces installed at window with new sealant installed from frame to trim and from trim to wall.

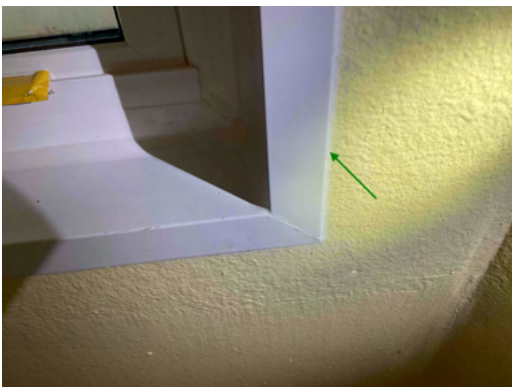
Photo 5

Unit No. 202 - View of new interior trim pieces installed at window with new sealant installed from frame to trim and from trim to wall.

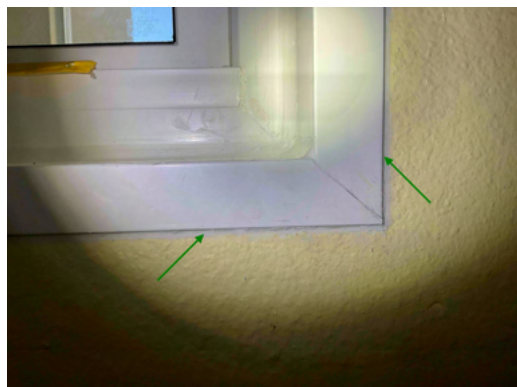
Photo 6

Unit No. 202 - View of new interior trim pieces installed at window with new sealant installed from frame to trim and from trim to wall.

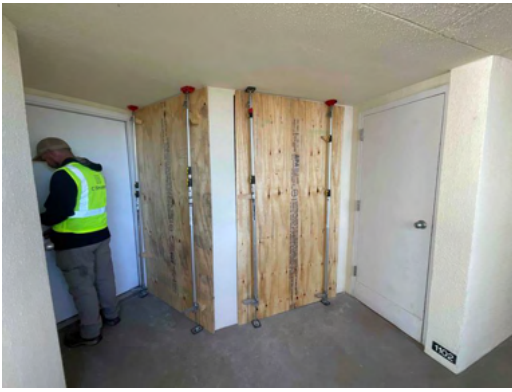
Photo 7
Unit No. 1102 - View of exterior protection installed at window replacement location.

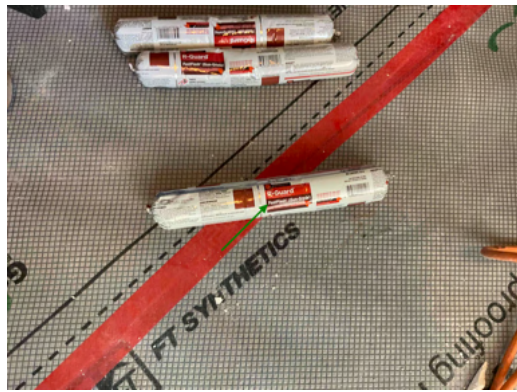
Photo 8
Unit No. 1112 - View of materials on site.

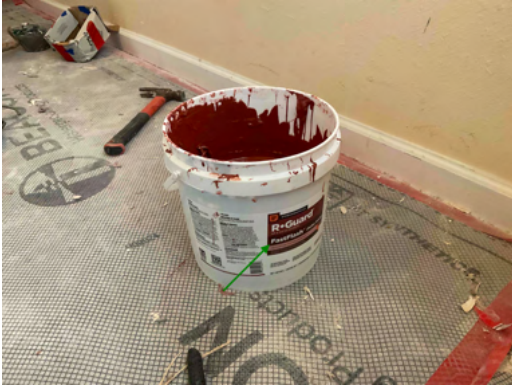
Photo 9
Unit No. 1112 - View of materials on site.

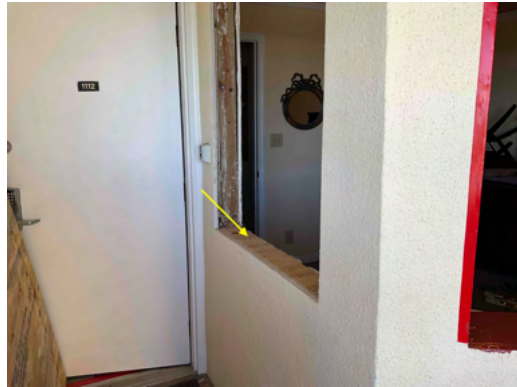
Photo 10
Unit No. 1112 - View of existing window removed - Work in progress.

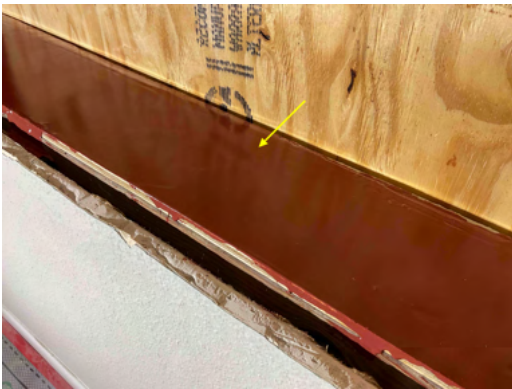
Photo 11
Unit No. 1104 - View of new FastFlash waterproofing installed at window rough opening - Work in Progress.

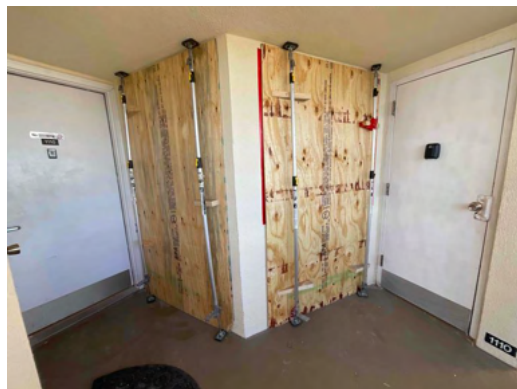
Photo 12
Unit No. 1110 - View of exterior protection installed at window replacement location.

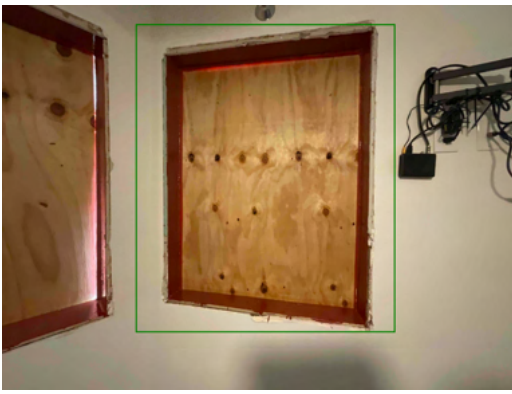
Photo 13

Unit No. 1110 - Overall view of new sill flashing installed at window rough opening.

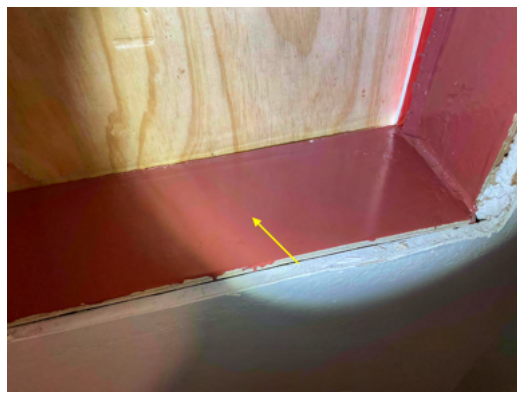
Photo 14

Unit No. 1110 - View of new FastFlash waterproofing installed at window rough opening - Work in Progress.

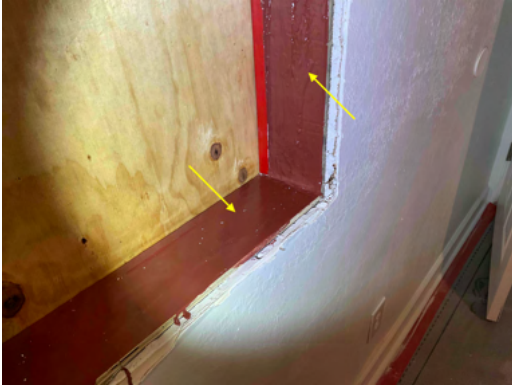
Photo 15

Unit No. 1110 - View of new FastFlash waterproofing installed at window rough opening - Work in Progress.

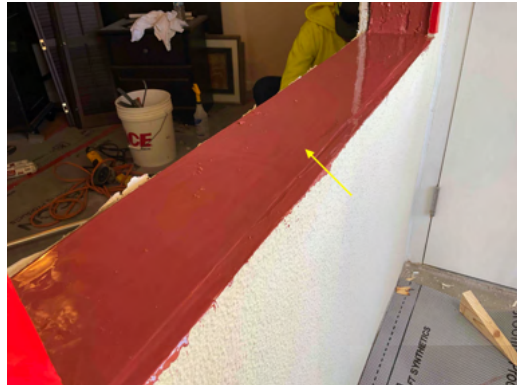
Photo 16

Unit No. 1112 - View of new FastFlash waterproofing installed at window rough opening - Work in Progress.

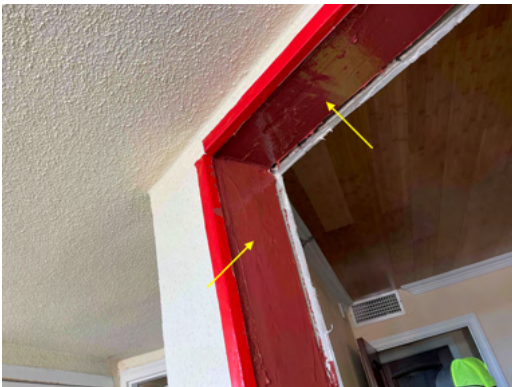
Photo 17

Unit No. 1112 - View of new FastFlash waterproofing installed at window rough opening - Work in Progress.

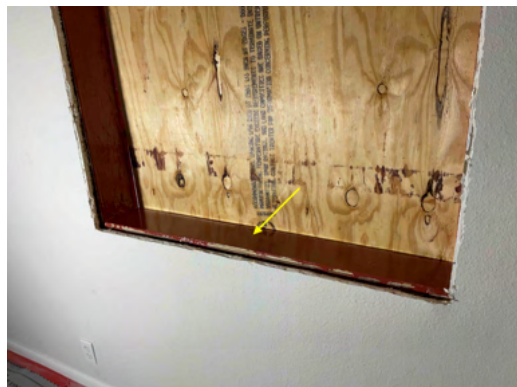
Photo 18

Unit No. 1104 - View of new FastFlash waterproofing installed at window rough opening - Work in Progress.

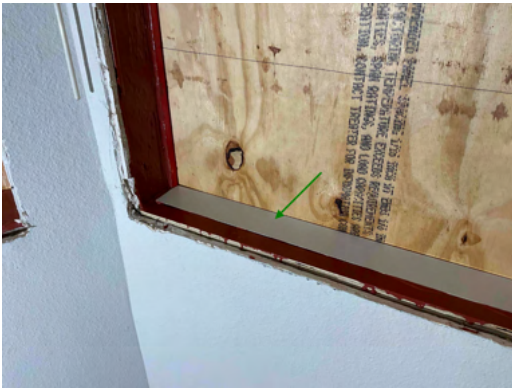
Photo 19

Unit No. 1104 - View of new sill flashing installed at window rough opening.

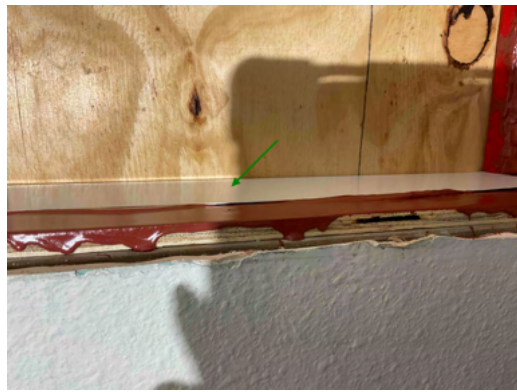
Photo 20

Unit No. 1104 - View of new sill flashing installed at window rough opening.
