BECI Field Report

Perdido Sun
13753 Perdido Key Dr.
Pensacola, FL 32507

FIELD REPORT NO: **PRDDSN002**
CONSULTANTS PROJECT NO: **P140741899**

Window Mock Up at Unit No. 202

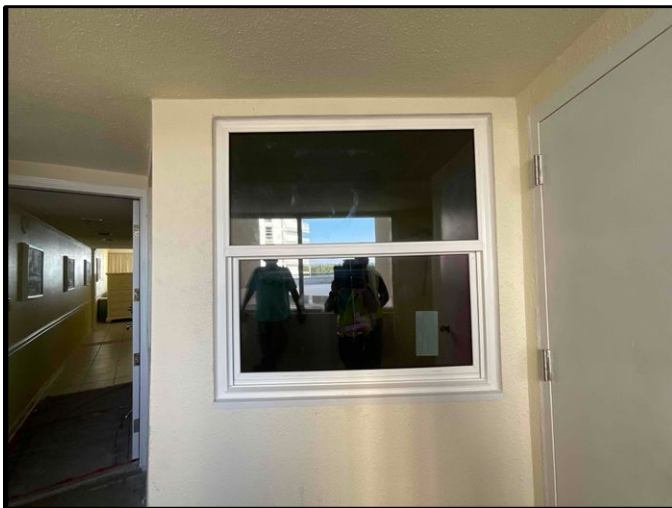
FIGURE 1 - Unit No. 202 - View of new PGT SH5500 Single-Hung window installed at common walkway - Work in Progress.

- 2.2 We observed the installation of new PGT SH5500 Single-Hung windows at the common walkway in Unit No. 202. The exterior side of the window mock-up had been completed (Reference Figures 1 and 2). Additionally, we observed the completed application of beading sealant and R-Guard, a Fluid Applied Flashing, at the rough opening of the new window. However, the interior mock-up and window trim installation are still in progress (Reference Figures 3 and 4). The Fluid-Applied Flashing appeared to be tooled smoothly over the untreated plywood bucking used at the rough opening. It is important to use untreated plywood to ensure that the waterproofing chemicals do not interfere with the chemicals used on treated lumber. The sill detail appeared to be performed in accordance with BECI's provided Sketch from 10-8-24. BECI will return to observe the completed installation on the interior during a future site visit. Overall, the new window installation appeared to have been completed according to the PGT Installation Instructions and Engineered Shop Drawings.

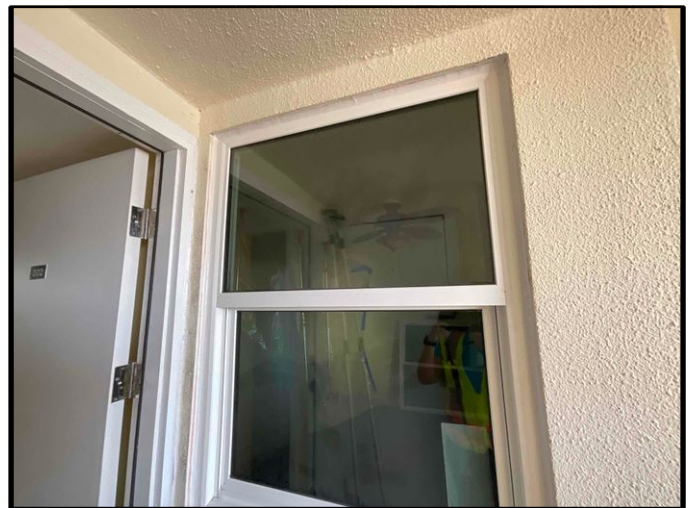
FIGURE 2 - Unit No. 202 - View of new PGT SH5500 Single-Hung window installed at common walkway - Work in Progress.

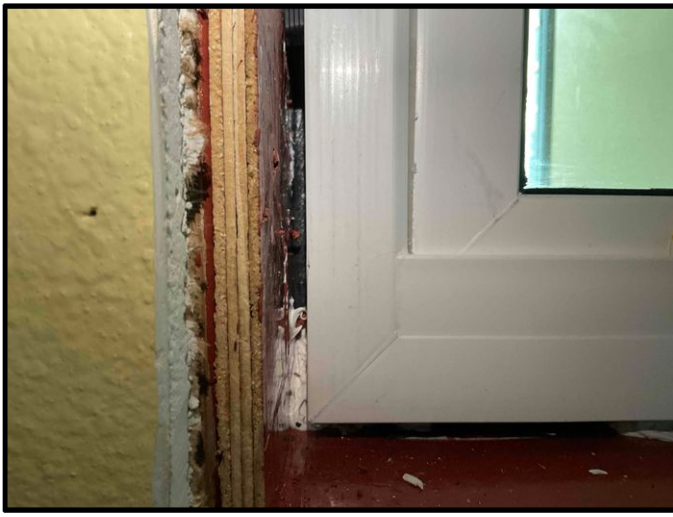
FIGURE 3 - Unit No. 202 - View of beading sealant and R-Guard installed at rough opening of new PGT SH5500 Single-Hung window installed at common walkway - Work in Progress.

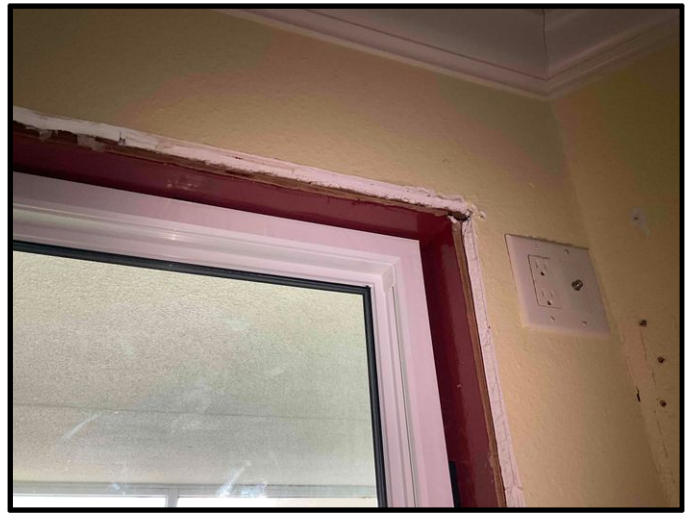
FIGURE 4 - Unit No. 202 - View of R-Guard installed at rough opening of new PGT SH5500 Single-Hung window installed at common walkway - Work in Progress.

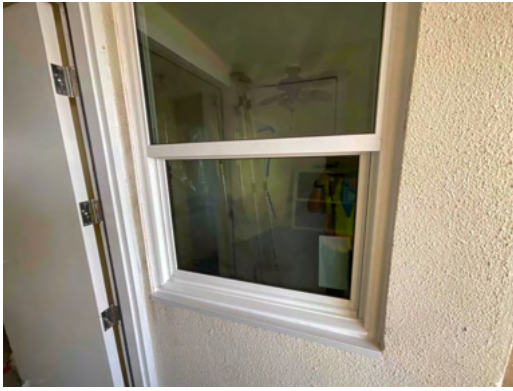
Photo 1

Unit No. 202 - View of new PGT SH5500 Single-Hung window installed at common walkway - Work in Progress.

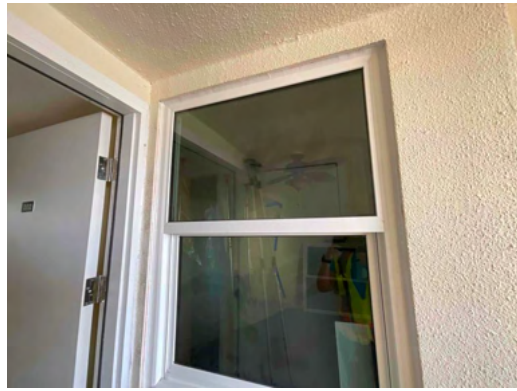
Photo 2

Unit No. 202 - View of new PGT SH5500 Single-Hung window installed at common walkway - Work in Progress.

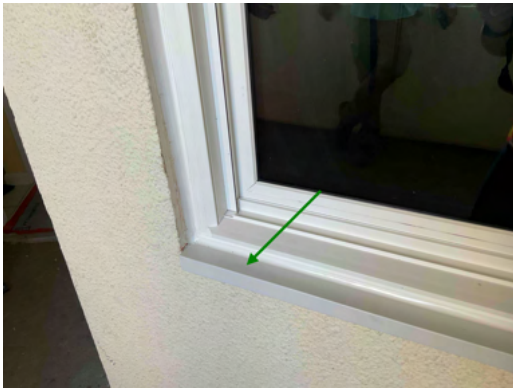
Photo 3

Unit No. 202 - View of new sill flashing installed at new PGT SH5500 Single-Hung Window - Work in Progress.

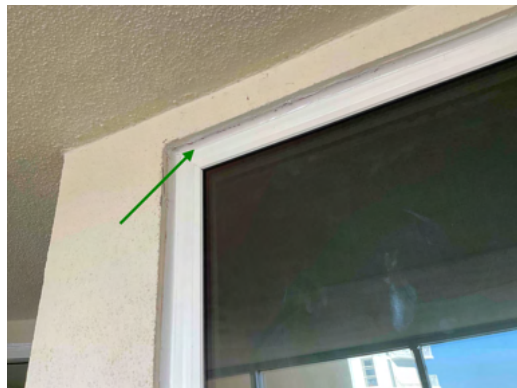
Photo 4

Unit No. 202 - View of cleanly tooled perimeter sealant at new PGT SH5500 Single-Hung Window - Work in Progress.

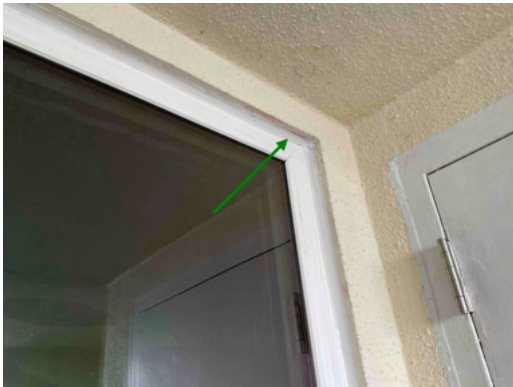
Photo 5

Unit No. 202 - View of cleanly tooled perimeter sealant at new PGT SH5500 Single-Hung Window - Work in Progress.

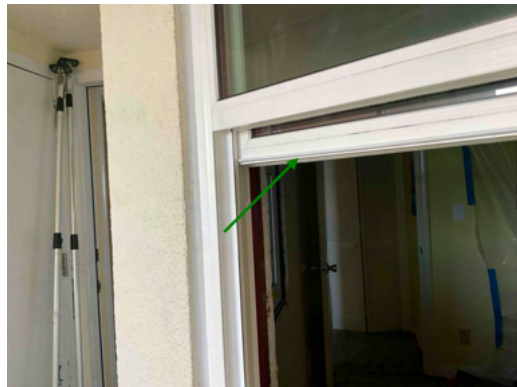
Photo 6

Unit No. 202 - View of operable panel operating as designed at new PGT SH5500 Single-Hung Window - Work in Progress.

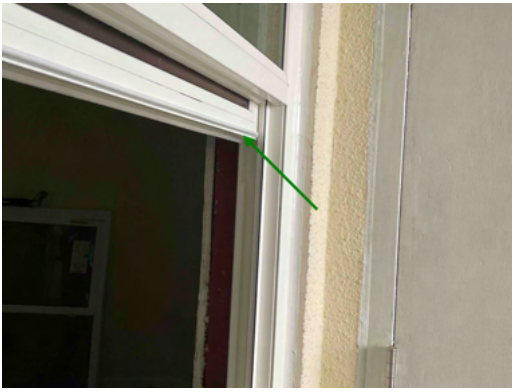
Photo 7
Unit No. 202 - View of operable panel operating as designed at new PGT SH5500 Single-Hung Window - Work in Progress.

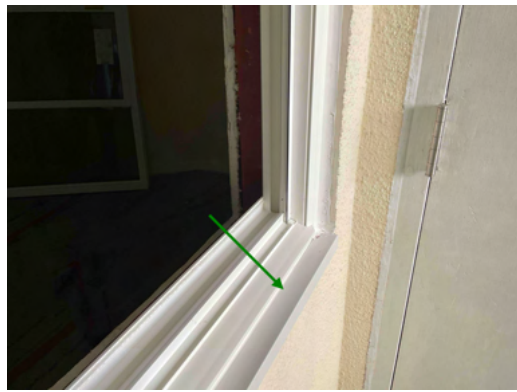
Photo 8
Unit No. 202 - View of new sill flashing installed at new PGT SH5500 Single-Hung Window - Work in Progress.

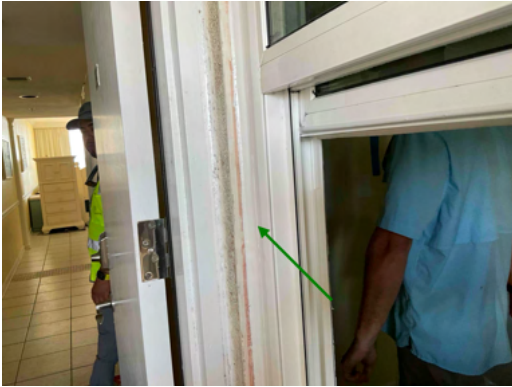
Photo 9
Unit No. 202 - View of cleanly tooled perimeter sealant at new PGT SH5500 Single-Hung Window - Work in Progress.

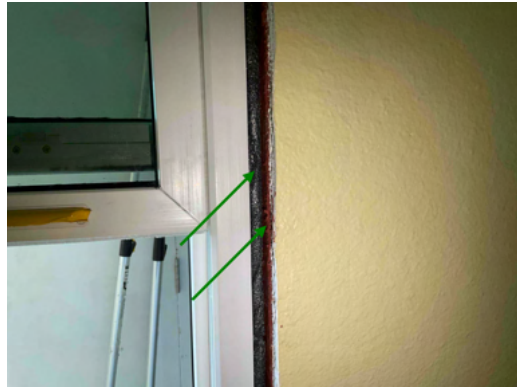
Photo 10
Unit No. 202 - View of Backer Rod and R-Guard installed at rough opening of new PGT SH5500 Single-Hung window installed at common walkway - Work in Progress.

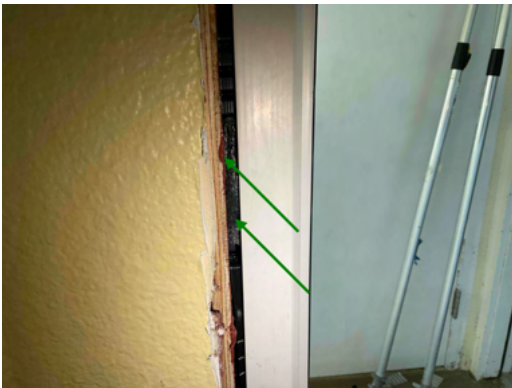
Photo 11
Unit No. 202 - View of Backer Rod and R-Guard installed at rough opening of new PGT SH5500 Single-Hung window installed at common walkway - Work in Progress.

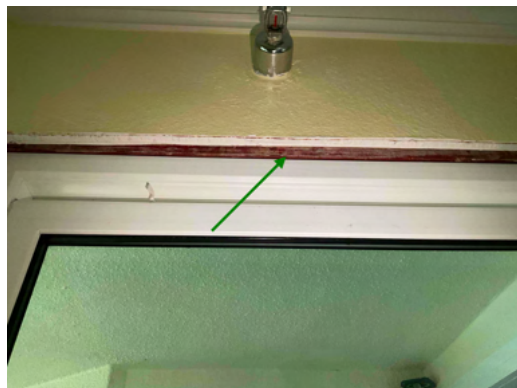
Photo 12
Unit No. 202 - View of R-Guard installed at rough opening of new PGT SH5500 Single-Hung window installed at common walkway - Work in Progress.

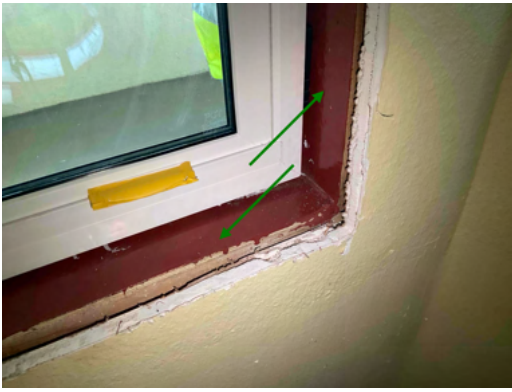
Photo 13
 Unit No. 202 - View of R-Guard installed at rough opening of new PGT SH5500 Single-Hung window installed at common walkway - Work in Progress.

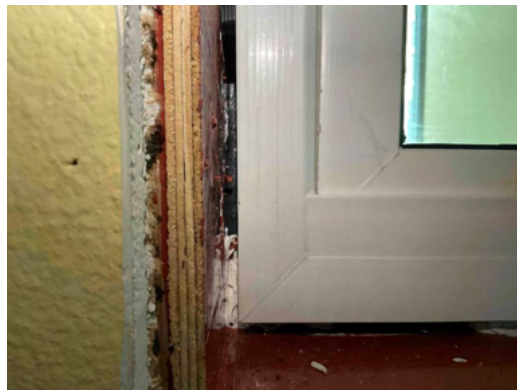
Photo 14
 Unit No. 202 - View of beading sealant and R-Guard installed at rough opening of new PGT SH5500 Single-Hung window installed at common walkway - Work in Progress.

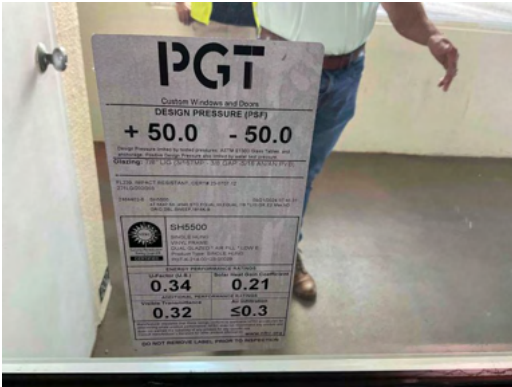
Photo 15
 Unit No. 202 - View of PGT Design Pressure Sticker on New Window.

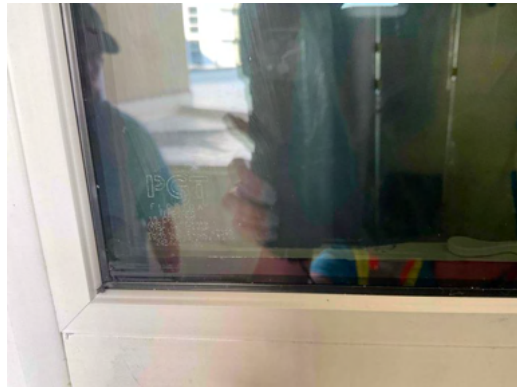
Photo 16
 Unit No. 202 - View of PGT ANSI Tempered Glass Label Sketched into window.
