Perdido Sun Condominium Owners Association 13753 Perdido Key Dr. Pensacola, FL 32536

Regarding: Perdido Sun Condominium – Window Perimeter Sealant

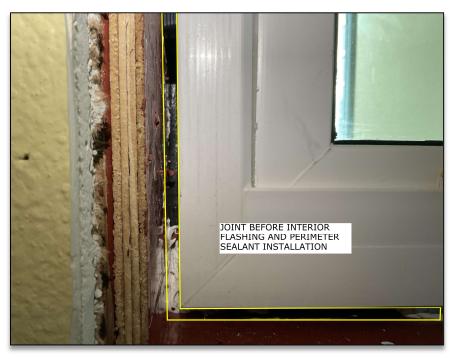
Figure 1 - View of Joint at Window Perimeter Before Interior Flashing and Perimeter Sealant Installation.

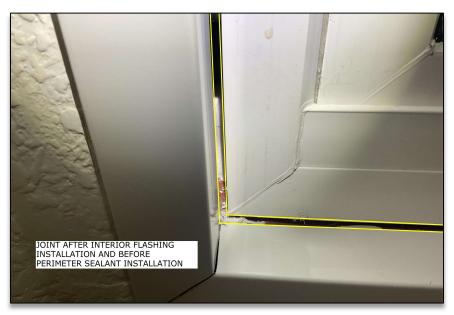
Figure 2 - View of Joint at Window Perimeter After Interior Flashing Installation and Before Perimeter Sealant Installation.

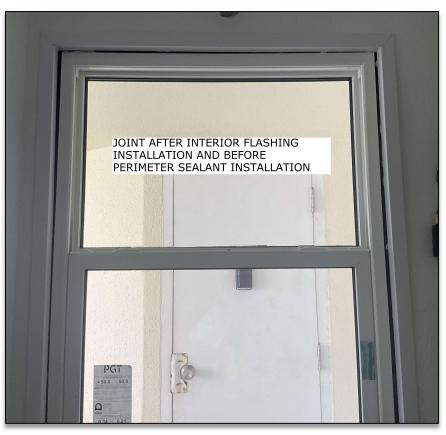
Figure 3 - View of Joint at Window Perimeter After Interior Flashing Installation and Before Perimeter Sealant Installation.

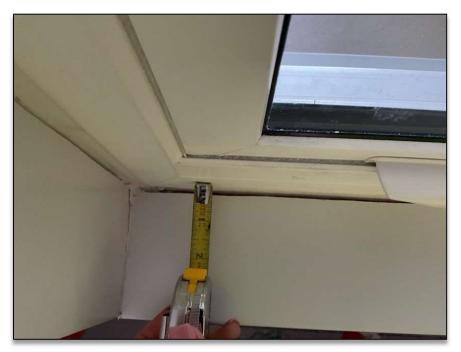
Figure 4 - View of Joint at Window Perimeter After Interior Flashing Installation and Before Perimeter Sealant Installation.

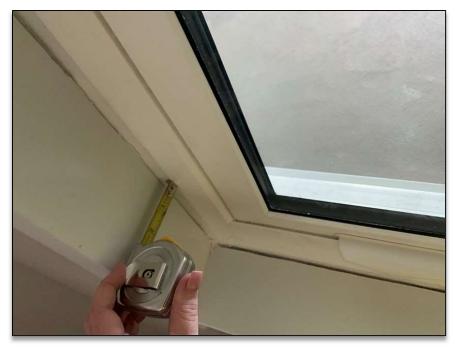
Figure 5 - View of Joint at Window Perimeter After Interior Flashing Installation and Before Perimeter Sealant Installation.
